CRACKING NOISES FROM RESIDENTIAL TIMBER FLOOR STRUCTURES CONSTRUCTED WITH ENGINEERED 'I' JOISTS

The Gypsum Products Association (GPA) has been investigating the noise phenomena of cracking noises from residential timber floor structures constructed with engineered 'I' joists spanning between solid masonry walls lined with plasterboard on gypsum adhesive. Guidance was produced in March 2016 and has now been updated with this version.

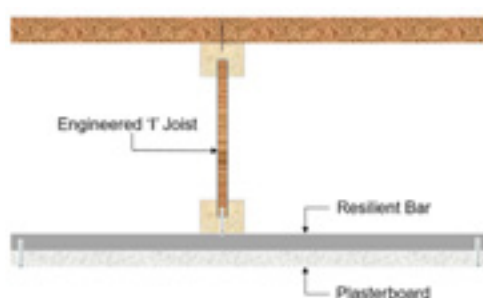
The latest research project has identified and concluded that a cracking noise is created due to the very minimal displacement that occurs between the timber engineered 'I' joist structure and plasterboard when the structure flexes.

A stick-slip action occurs at the junction/interface between the timber engineered 'I' joist, plasterboard ceiling, and drylining plasterboard bonded ('dot and dabbed') to the masonry wall.

In respect of the potential modifications the findings have reconfirmed the existing cross industry advice of providing a resilient layer (e.g. via metal resilient bars) between timber engineered 'I' joist and ceiling plasterboard is effective, and remains an appropriate mitigation option. See Fig 1.
